Advisory Visit
Annan Water - River Annan
Scotland
30/08/2016

1.0 Introduction

This report is the output of a site visit to a short section of the Annan Water at the request of Tony Donnelly, director of the River Annan Trust. The purpose of the visit was to assess bank erosion and riverine habitats and offer recommendations for future management at the site.

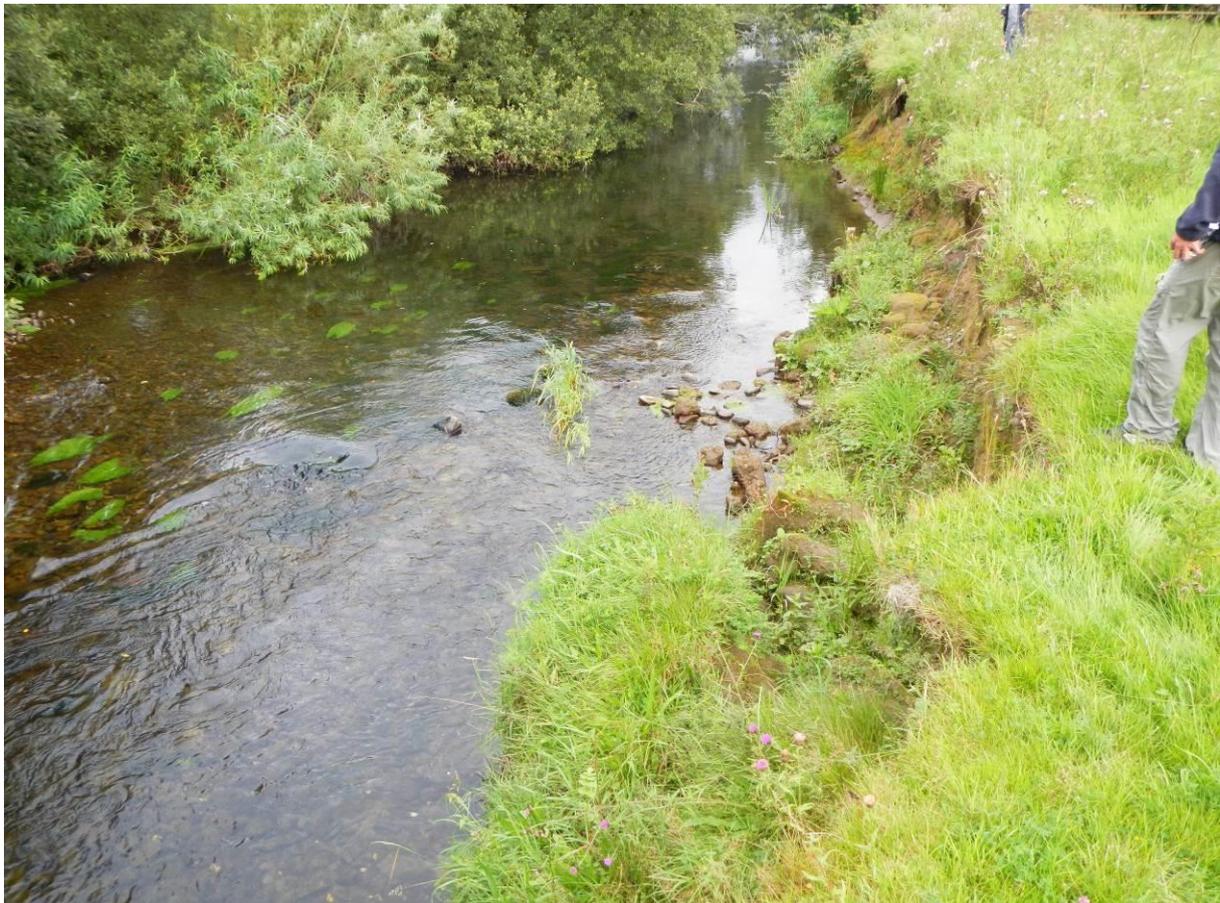
When assessing river banks within pasture fields it is common to find over-grazing to be a major issue but at this site grazing pressure appeared relatively low (Fig. 1). Even so, light grazing still limits the diversity of herbaceous vegetation (and natural tree regeneration) that can establish, as only grasses are capable of withstanding continual grazing pressure (leaving only grasses and unpalatable species).

In most areas, root structure within the banks remains sufficient to consolidate slumped bank material, retaining turfs intact at the toe of the bank (possibly less-so at times of greater grazing pressure)(Figs 1 & 2). This is important if the material is to remain part of the bank and facilitate natural regrading, rather than being washed away. Some of the slumped areas facilitate the formation of small grassy bars which encroach into the channel; these provide beneficial width variation and habitat features within the straightened and rock armoured (RB) channel. Modified channels invariably provide poorer habitat than sinuous ones, where meanders provide greater width and depth variation.

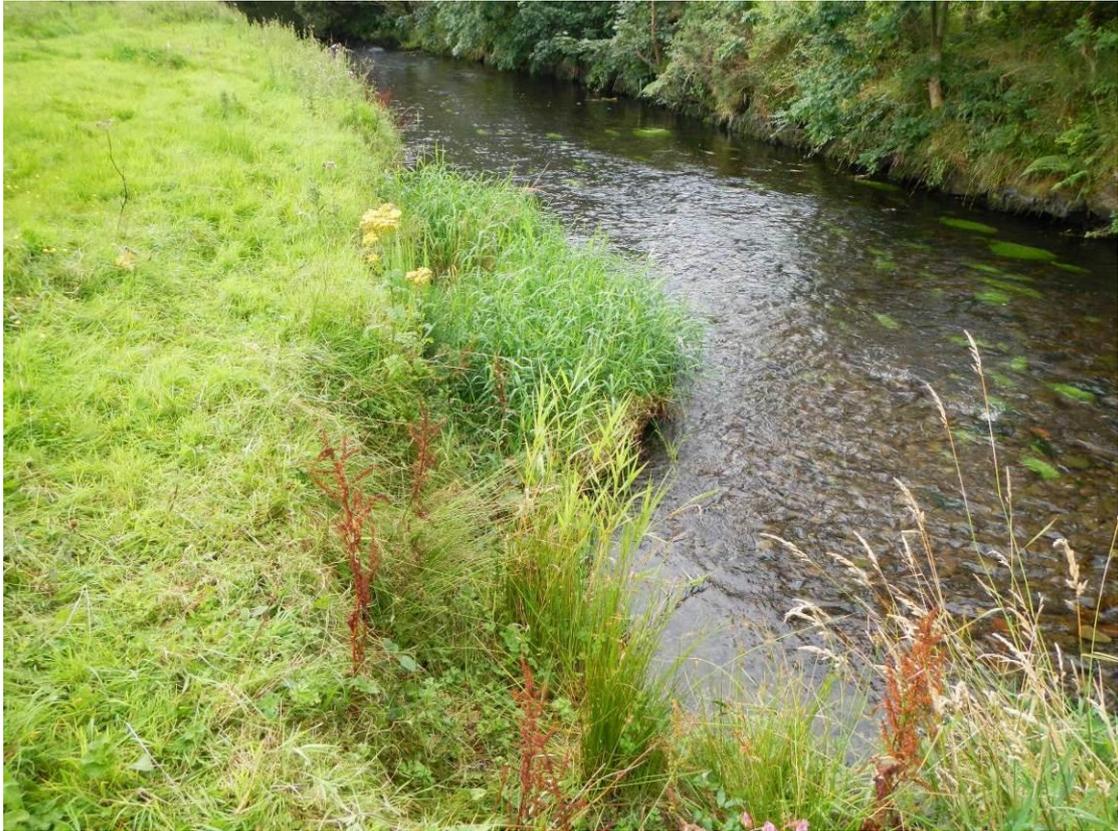
Figure 1. Signs of natural bank regrading where slumped bank material has remained in place long enough to become consolidated. Vegetation that then trails into the channel provides important cover and shelter for fish and invertebrates. Note the straight channel and hard, rock-lined/walled far bank. Some reasonable quality juvenile habitat is available but the area lacks the natural habitat diversity that would be expected within a sinuous channel.

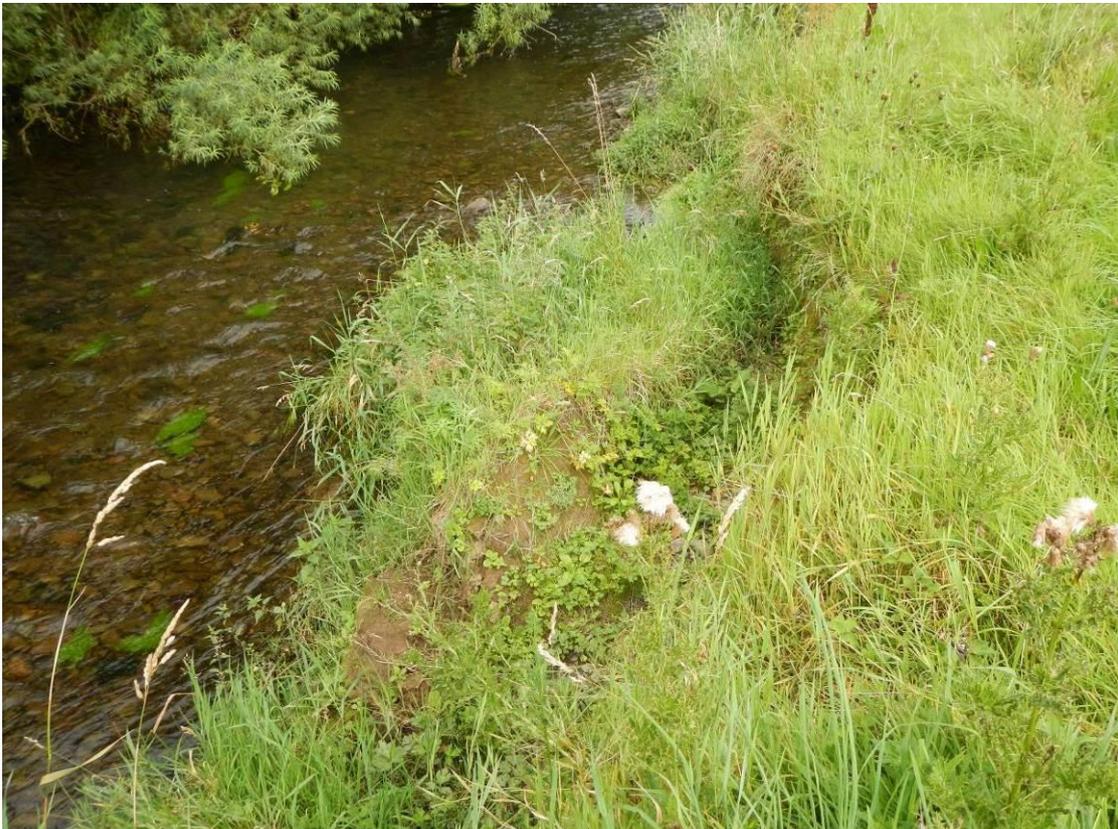
Figure 2. A large clump of bank material that has remained intact due to the presence of good root structures within it. Some such pieces will be lost in high flows but others will be retained to form a more stable, sloping bank that is less susceptible to erosion than the steep vertical banks. If retained, such features also provide valuable channel width variation.

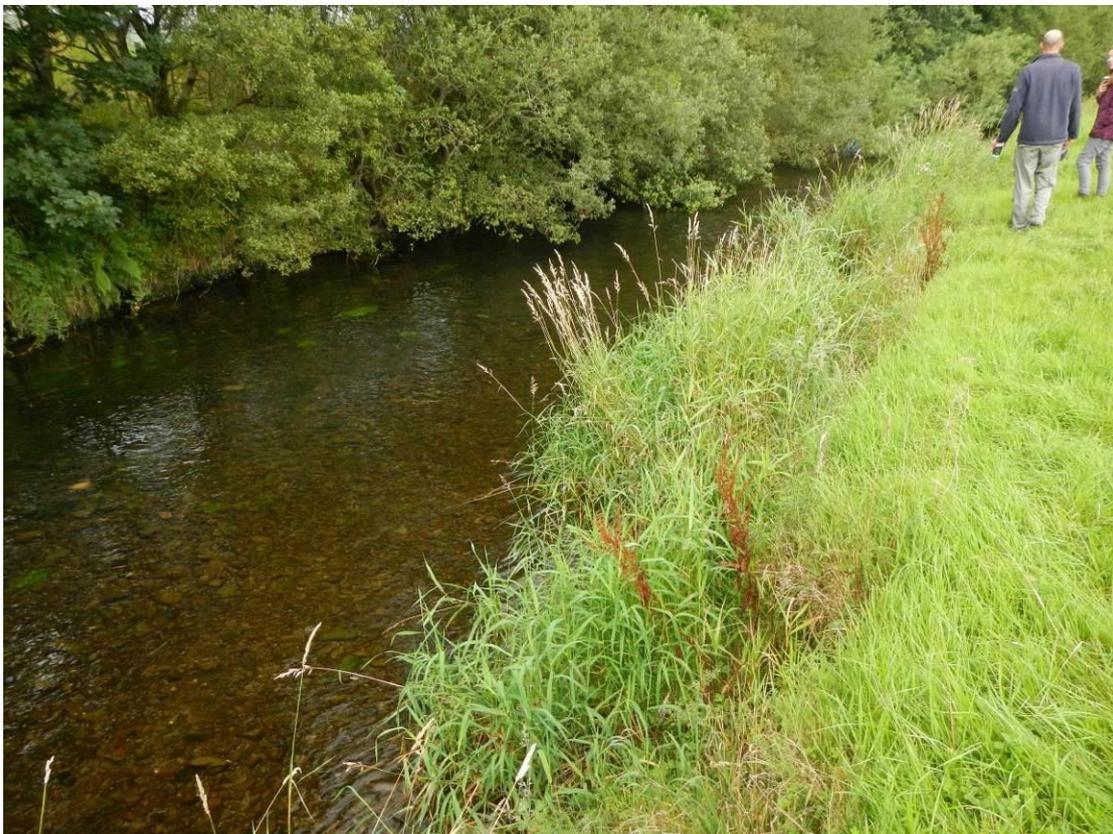
Figure 3. Overhanging and trailing willows provide vital cover and structure within the channel and help develop deeper pool habitat.

Where willow trees have become established they provide much needed cover and structure within the channel, creating refuge for fish from high flows and predators. The structure also helps to focus higher flows, driving scour into the bed to develop vital deeper pool habitat – something that is unlikely to occur otherwise within a straightened channel. It has to be conceded that structure within the channel may place some additional pressure upon the banks in high flows and could exacerbate erosion on the adjacent bank. For this reason, it is important to maintain a healthy diversity of vegetation on those banks by excluding livestock, if possible, but also by addressing other potentially significant issues such as Himalayan balsam (*Impatiens glandulifera*). Balsam often outcompetes native species but then dies back in winter, leaving a dearth of protection on top of and within the bank, thereby greatly exacerbating erosion issues.

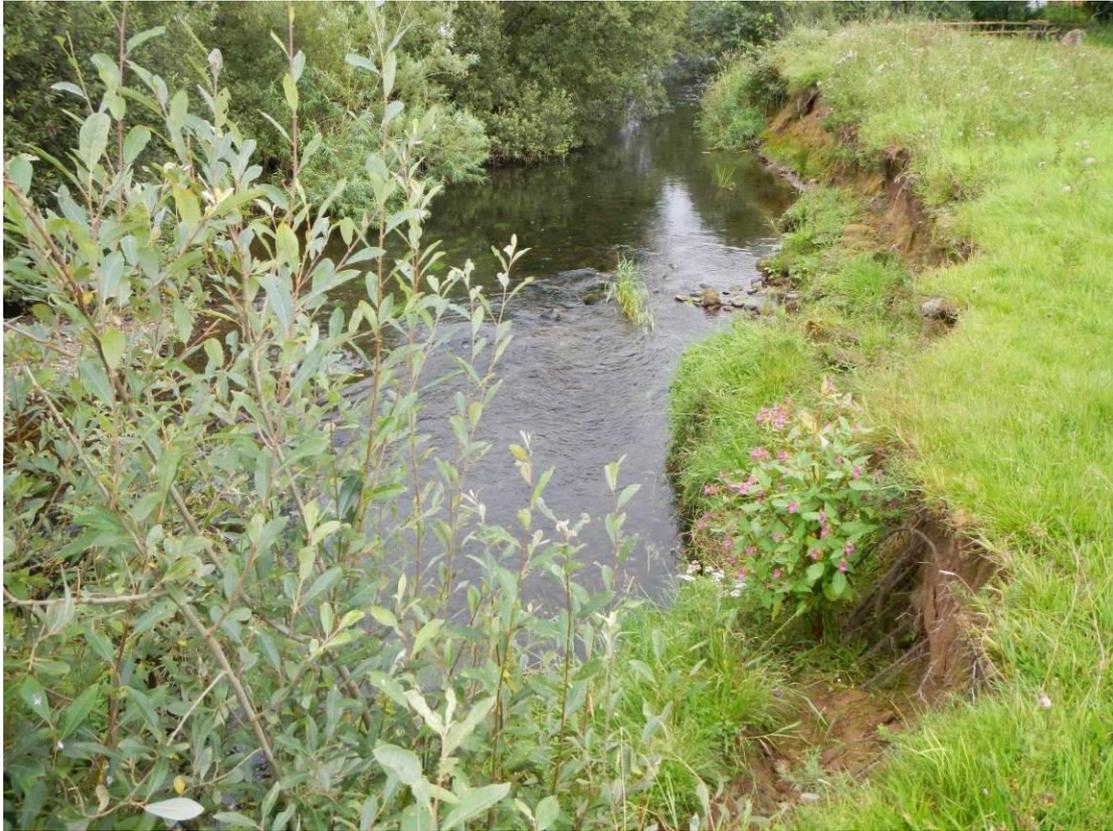
Figure 4. The area of greater erosion, likely exacerbated by high winter flows, balsam, dredging u/s, grazing (still limiting the root structure within the bank) and the willows on the far, RB (left of shot). Of these impacts they could all be addressed to the benefit of the surrounding habitat, except the willows, which provide vital in-channel habitat in their own right and should be retained. If the bank can be naturally protected with vegetation the erosion can be controlled and erosive forces will, instead scour the bed of the watercourse, developing and maintain the pool feature.

Other than that, the habitat throughout the majority of the field is reasonably good and the banks are naturally stabilising. Planting the odd tree, out of the reach of the horses may also be beneficial to increase species diversity. At the upstream end of the reach, where the greater extent of erosion is occurring, some intervention may be desirable but is not necessarily required if the bank face can be encouraged to revegetate.

Planting the eroding section of bank, ideally along the waterline as well as the bank face is likely to increase bank stability. This would create additional low-level cover and flow dissipation. However, bank erosion was not considered to be a major issue from an ecological perspective, and some degree of erosion is beneficial, being a natural aspect of riverine processes.

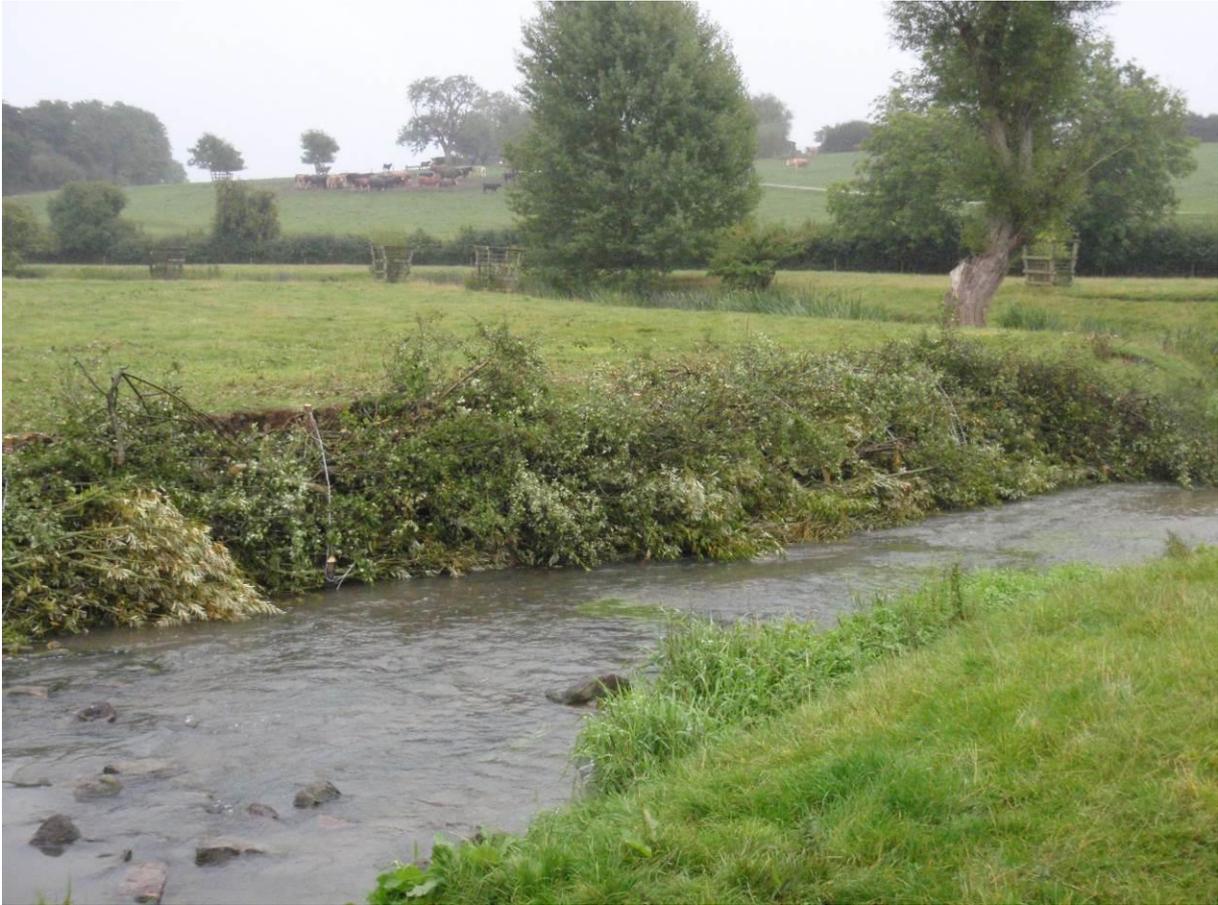
Figure 6. Mixed brash bank protection.

If it is considered that a greater level of intervention is required, a more formal brash (small branches) bank protection could be installed. The method involves securing a line of diffuse brash structure along the bank to dissipate flow energy before it hits the bank, encouraging suspended sediment to be deposited within the structure which will subsequently become consolidated by vegetation. The technique usually employs at least some live willow which will ultimately take root and form a line of shrubs along the bank. However, if the potential requirement for maintenance is considered particularly undesirable, the same technique could be used employing dead brash which would not take root. The idea being to simply protect the bank long enough for it to fully revegetate and become stable. Posts are driven into the bank, to which the brash is wired.

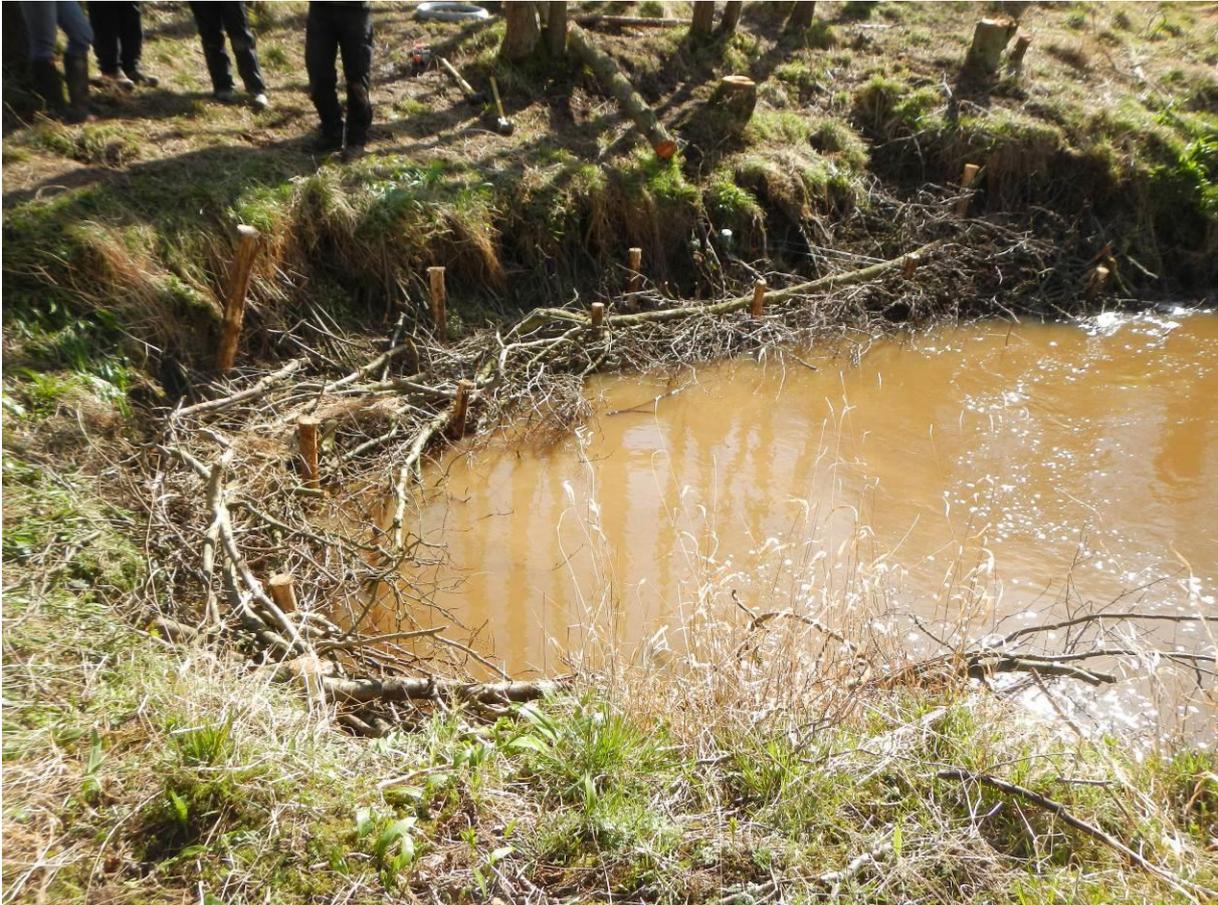
Figure 7. Dead brash bank protection employed to create a diffuse barrier along the bank.
